Nine Years of Volunteer Biomonitoring in Western North Carolina Streams

Stream Monitoring Information Exchange Year 2013

Technical Report No. 2014-1

ENVIRONMENTAL QUALITY INSTITUTE

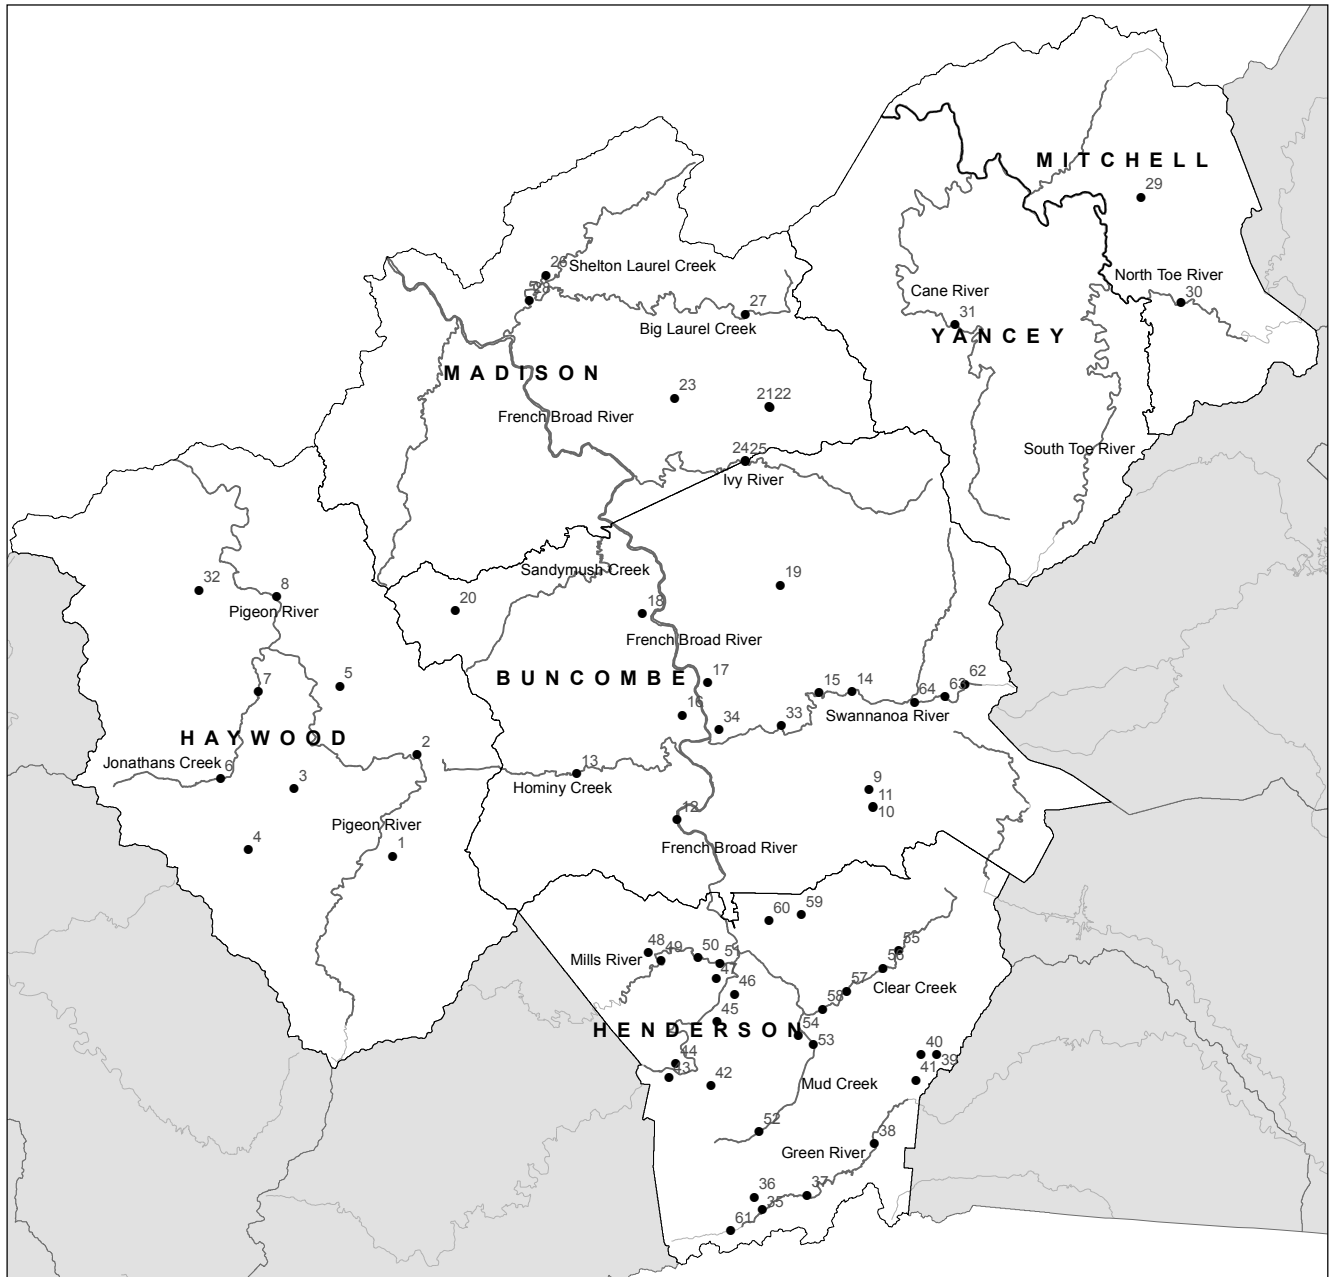
Figure 1. Map of 2013 SMIE Monitoring Sites

In 2013, EQI's core SMIE program conducted biannual sampling at 36 sites, while ECO sampled 20 additional sites in Henderson County following the SMIE protocol. Figure 1 depicts the locations of sites Haywood, Buncombe, Madison, Mitchell, Yancey and Henderson Counties. Table 1 lists of all SMIE monitoring sites in the region. Results are available through technical reports that can be accessed at EQI's website (www.eqilab.org), ECO's website (www.eco-wnc.org), or by request. These websites also have online SMIE training videos, which cover basic stream ecology, macroinvertebrate identification, sampling protocols, and habitat assessment.
